BELZONA SUPERWRAP II MEETS GAS PIPELINE OPERATOR REQUIREMENTS

ID: 5954

20" Gas Pipeline Riser on Offshore Production Platform

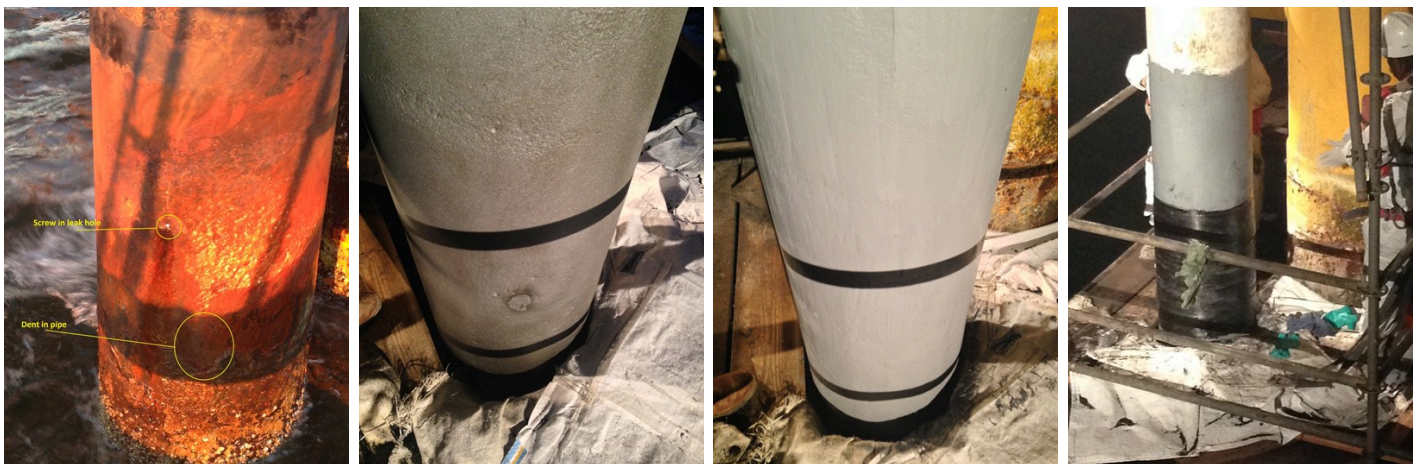
External corrosion led to a through-wall defect causing the platform to be temporarily shut down. The operator required a permanent repair compliant with DOT Standards. Traditional repairs required fabrication, causing extended downtime and production loss.

- * Riser with defects indicated. ,
- * Belzona 1291 plug and surface profile after blast. ,
- * Skim coat of Belzona 1161 for pit filling and leveling surface. ,
- * Completed SuperWrap II application, 4 wrap (8 layers) system. ,

The repair area was very close to the waterline and had to be protected from wave action. Also, the application had to be completed at low tide. The riser was out of service, but there was some seepage from the through-wall defect and Belzona 1291 was used to plug the hole, allowing for a dry surface during blasting and application. Abrasive blast with angular grit was used to clean the surface to the requirements of SSPC SP-10 (Near White Metal) with an average anchor profile of at least 3 mils. Belzona 9111 was used to clean and remove all surface contaminants. Because of occasional spray and moisture in the area, Belzona 1161 was used to fill pits and level surface irregularities. Belzona 9381 was saturated with Belzona 1982 and applied in 4 wraps (8 layers) in compliance with the engineered design. Belzona 9382 was installed to consolidate the repair during the curing process and removed once the system was cured.
