BELZONA SUPERWRAP II STRENGTHENS CORRODED GAS PIPE

Industry: Oil & Gas
Application: VPF-Valves, Pipes and Fittings
Substrate: Carbon Steel
Products: * Belzona Superwrap II ,
* Belzona 1111 (Super Metal) ,
* Belzona 1311 (Ceramic R-Metal) ,

Customer Location: FPSO, North Sea, Norway
Application Date: April 2015

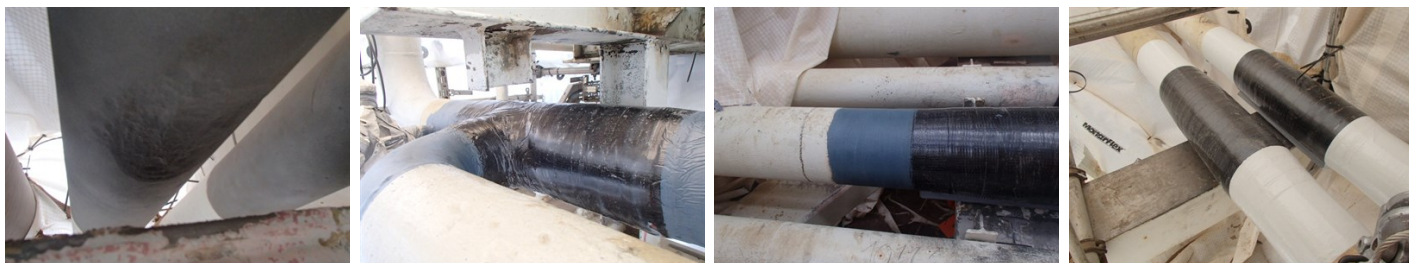
Photograph Descriptions

- * Thin-wall corrosion up to 35% ,
- * Belzona SuperWrap II tackles complex geometries ,
- * Belzona shim plates at pipe supports ,
- * Complete Belzona SuperWrap II application ,

A series of pipes on board the North Sea FPSO were displaying signs of corrosion between the pipe and support. In some areas, registering thin wall defects, with 35% wall loss.

Corrosion resistant Belzona 1111 was used to rebuild the metal substrate before application of the Belzona Superwrap II system. The reinforcement sheets were accurately cut to match the unique pipe dimensions in the form of a reinforcement jackets for the Tees, whilst utilising specifically measured strips for the bends. The applicators used seven spirals of Belzona SuperWrap II around each defect. Following completion of the SuperWrap II installation, Belzona 1311 was used to create irregular loading bearing shims between the pipeline and support in accordance with Belzona System Leaflet VPF-15.
