AGITATOR SHAFTS CURED WITH BELZONA

ID: 597

Industry: Oil & Gas
Application: MPT-Mechanical Power Transmission

Customer Location: Oil Processing Facility, Liverpool, UK
Application Date: July 2005

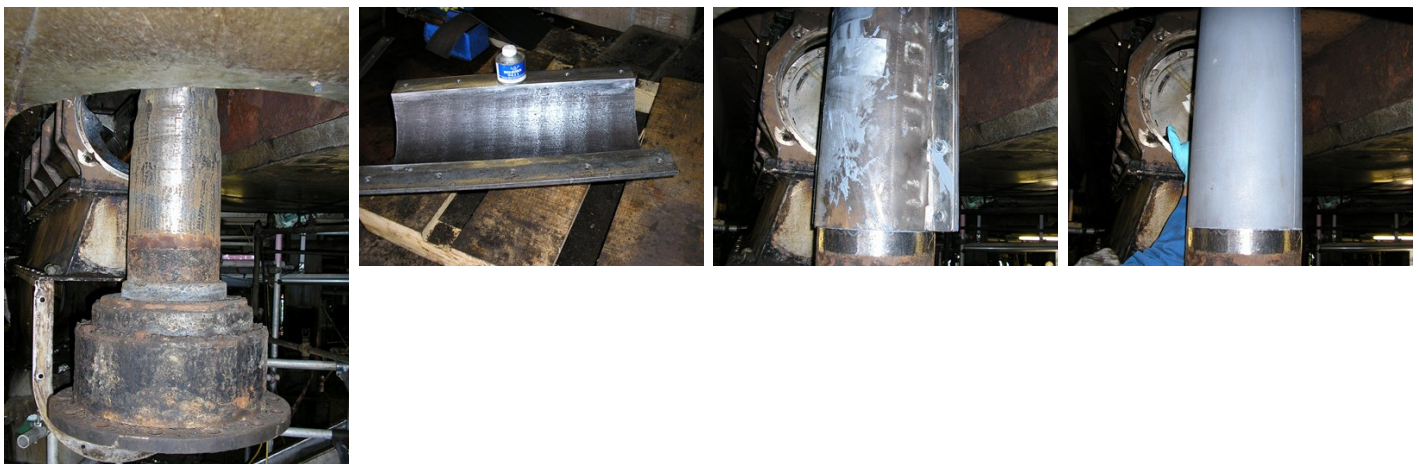
Photograph Descriptions

The main shaft on the agitator had worn down under the stuffing box over a number of years by up to 2" overall on the diameter over 21" of the shaft length.

- * The shaft in situ showing the extent of the damage ,
- * The former ready to be applied ,
- * The former in place after application of the material ,
- * The finished shaft with only a small split line requiring dressing ,

Application was carried out in accordance with Belzona® Know-How System Leaflet MPT-2.

Belzona was chosen to repair the shaft in-situ as being over 40ft long its removal would have required the dismantling of the building and several items of plant it ran through. With Belzona the shaft was repaired in less than 4 hours and left to cure overnight to reveal a perfectly reformed area that was able to receive the stuffing box and get production started on schedule saving a massive amount of downtime. They have since gone on to complete several other smaller scale shaft repairs the same way.
