BELZONA REPAIRS LEAKING TANK AT FOOD FACTORY

ID: 5977

Industry: Food & Drink
Application: TCC-Tanks and Chemical Containment Areas
Substrate: Carbon Steel
Products: * Belzona 1161 (Super UW-Metal) ,
* Belzona 5811 (Immersion Grade) ,

Customer Location: Food Producer, Skopje, Macedonia
Application Date: November 2015

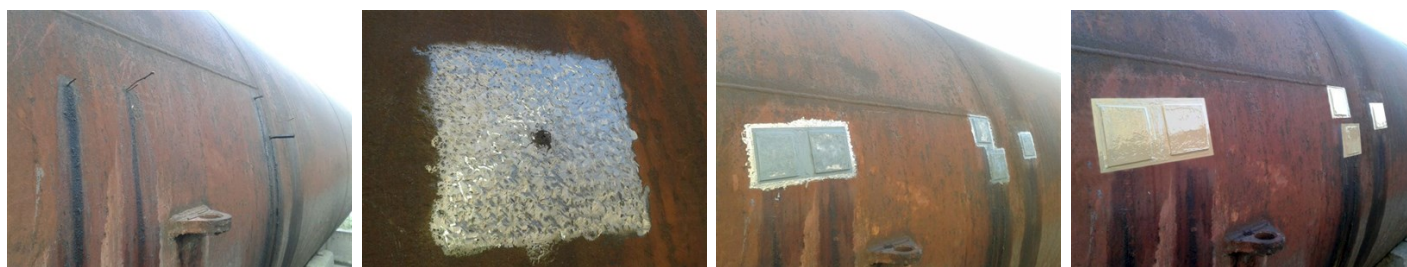
Photograph Descriptions

Horizontal steel tank was suffering from corrosion, which had led to through-wall defects, all located at the bottom of the vessel. The customer had been using wooden pegs to plug the holes.

- * Wooden pegs plug leaking tank ,
- * Surface preparation around defect ,
- * Metal plates bonded with Belzona 1161 ,
- * Repairs coated with Belzona 5811 ,

The application was carried out in accordance with Belzona Know-How System Leaflet TCC-1. Belzona 1161 was selected to bond metal plates over the defects. Each of these areas were then coated with Belzona 5811 to protect from further corrosion damage.

The customer was after a quick fix as opposed to a long-term solution. Also, the tank was rotated in order to relocate the holes in the upper surface of the tank, thus preventing pressure leaks. Belzona 1161 surface tolerant properties ensured high bond strength to the contaminated tank surface.
