TOUGH AND LASTING BELZONA PROTECTION FOR PUMP IN DESULFURIZATION UNIT

ID: 5981

Customer Location: Power Plant, La Spezia, Italy

Rubber coated pump cone in a desulfurization unit at a fossil power plant.

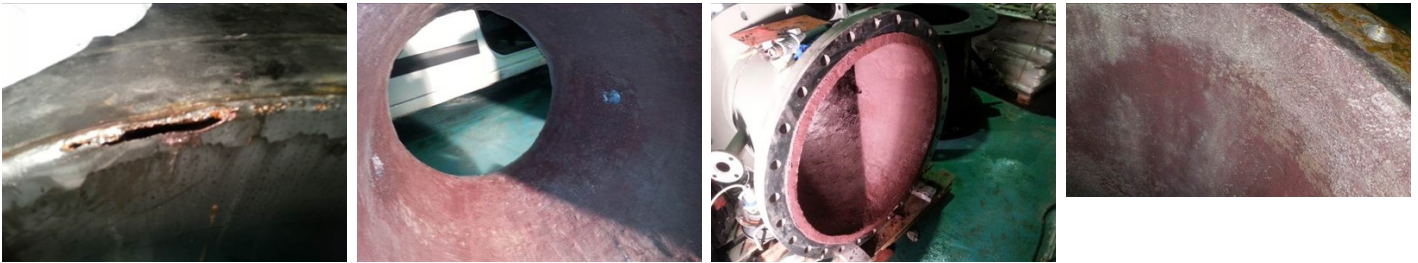
Photograph Descriptions

The cone was suffering from severe dry abrasion in the presence of strong concentrations of sulfides. Previously applied rubber coating started to peel, leading to leakages between flange couplings. Leaking corrosive substance in turn attacked the underlying metallic substrate, thus reducing the efficiency and the working life of this component.

- * Original holed rubber lining ,
- * Application of Belzona 1811 ,
- * Application of Belzona 1811 ,
- * Inspection after 1 year in service ,

The application was carried out in accordance with Belzona Know-How System Leaflet SHM-13. The failed rubber coating was removed, the substrate was then grit blasted and a thick layer of Belzona 1811 was applied to protect the cone from further abrasion damage.

This Belzona solution succeeded where a competitive system had failed. After a year in service, Belzona 1811 is still in a as new condition, to the customer's delight. The Belzona solution effectively enhanced efficiency and the working life of this component.
