LIVE LEAKS STOPPED AND SEALED WITH BELZONA

ID: 5982

Industry: Chemical & Petrochemical
Application: TCC-Tanks and Chemical Containment Areas
Substrate: Carbon Steel
Products: * Belzona 1212 ,

Customer Location: Tank Farm, Genova, Italy
Application Date: December 2015

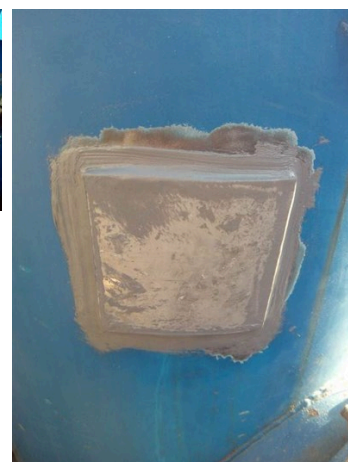
The tanks suffered from severe corrosion up to through-wall defects with some live seawater leakage. It was only possible to stop the filtration plant for two hours.

- * General view of equipment ,
- * Detailed leakage ,
- * Plate bonded with Belzona 1212 ,
- * Close up of one of the bonded plates ,

The application was carried out in accordance with Belzona Know-How System Leaflet TCC-1. Surface preparation was carried out using an MBX bristle blaster. Several metal plates were cold bonded with Belzona 1212 to cover thin wall and through wall defects.

For a traditional weld repair, the customer would have to shut down the system and completely empty the tanks. Due to its surface-tolerant and fast-curing properties, Belzona 1212 was applied directly onto leaking tanks, bypassing the need for a shutdown. In a couple of hours the customer forgot about his problem.
