# LIVE LEAKS STOPPED AND SEALED WITH BELZONA

Industry: *Chemical & Petrochemical*  
Application: *TCC-Tanks and Chemical Containment Areas*  
Substrate: *Carbon Steel*  
Products: *\* Belzona 1212 ,*

Customer Location: *Tank Farm, Genova, Italy*  
Application Date: *December 2015*

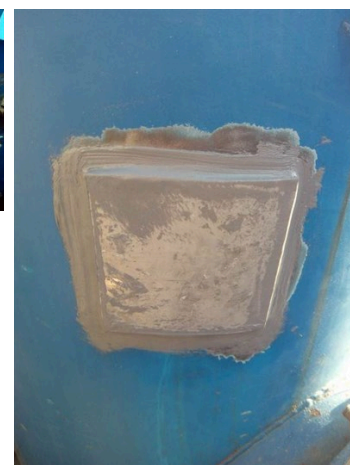
*The tanks suffered from severe corrosion up to through-wall defects with some live seawater leakage. It was only possible to stop the filtration plant for two hours.*

- \* General view of equipment ,
- \* Detailed leakage ,
- \* Plate bonded with Belzona 1212 ,
- \* Close up of one of the bonded plates ,

The application was carried out in accordance with Belzona Know-How System Leaflet TCC-1. Surface preparation was carried out using an MBX bristle blaster. Several metal plates were cold bonded with Belzona 1212 to cover thin wall and through wall defects.

For a traditional weld repair, the customer would have to shut down the system and completely empty the tanks. Due to its surface-tolerant and fast-curing properties, Belzona 1212 was applied directly onto leaking tanks, bypassing the need for a shutdown. In a couple of hours the customer forgot about his problem.
