BELZONA PROTECTS NEW PROCESS VESSELS FOR NATURAL GAS PURIFICATION PLANT

ID: 5985

Customer Location: Major Oil and Gas Customer, China
Application Date: August 2014

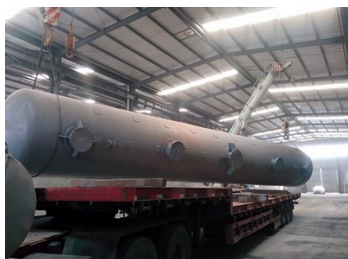
- * Overview of some vessels ,
- * Overview of interior of the vessels after blasting ,
- * Application completed and inspected ,
- * After 1 year in service, the re-inspection showed a "flawless" lining ,
