# BELZONA PROTECTS NEW PROCESS VESSELS FOR NATURAL GAS PURIFICATION PLANT

Industry: Oil & Gas  
Application: TCC-Tanks and Chemical Containment Areas  
Substrate: Carbon steel  
Products: \* Belzona 1321 (Ceramic S-Metal) ,  
\* Belzona 1391T ,  
\* Belzona 1591 (Ceramic XHT) ,

Customer Location: Major Oil and Gas Customer, China  
Application Date: August 2014

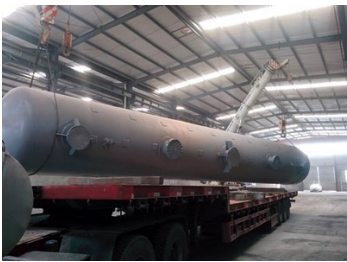
- \* Overview of some vessels ,
- \* Overview of interior of the vessels after blasting ,
- \* Application completed and inspected ,
- \* After 1 year in service, the re-inspection showed a "flawless" lining ,

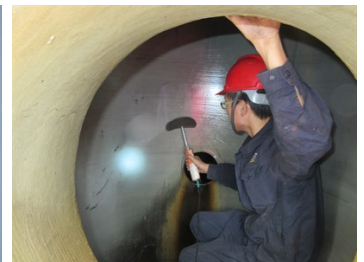
The Belzona internal linings have been a cost effective solution, protecting the vessels from aggressive erosion and corrosion, while ensuring the plant operated safely. The application team was well trained by Belzona and strictly implemented the Belzona global application standard which enabled the application to be delivered to a high standard. After immersed in aggressive media such as acid solvent, sour gas and sediment for 1 year, when the vessels were inspected on-site, the internal lining showed no signs of deterioration.
