BELZONA SEALS FLANGE ON VACUUM DRYER

ID: 5986

Customer Location: Food Process, Girvan, Scotland
Application Date: November 2015

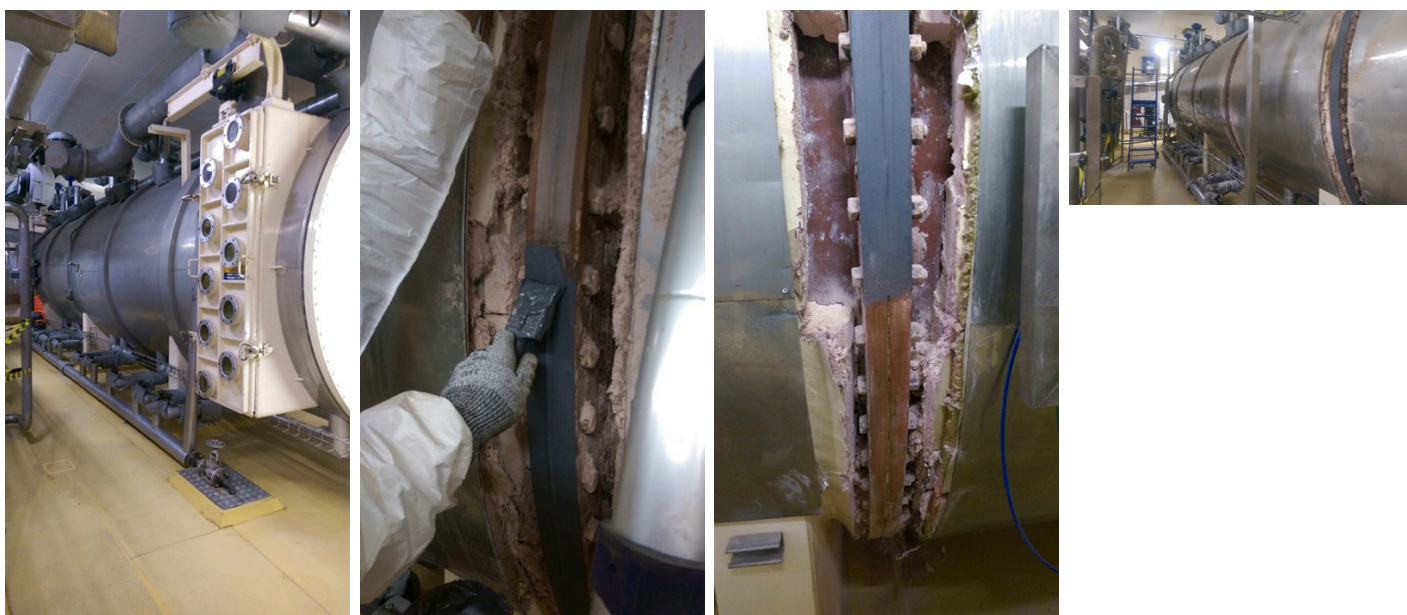
Photograph Descriptions

A leak around the flange had developed, preventing a vacuum to be accurately maintained within the vessel. This was affecting the drying process and production. A solution to seal this leak around the flange was required without dismantling the equipment. When the vessel is in operation it runs at elevated temperatures.

- * Vacuum vessel ,
- * 1st coat of Belzona 5851 applied with Belzona 9341 ,
- * Application in progress ,
- * Completed flange seal ,

The application was carried out in accordance with Belzona Know-How System Leaflet VPF-11 while the vessel was running at temperature. The surface temperature was maintained at 90 to 110°C. After preparing the substrate, Belzona 5851 was applied as a 3 coat system in conjunction with Belzona 9341. By drawing a vacuum from within the vessel, the Belzona 5851 material was actually pulled into the void areas before curing off. This ensured all the leak areas were attended to and sealed.
