# Belzona repairs damaged floor in a warehouse

Industry:	General Industry	Customer Location:	Cement plant in Croatia
Application:	FPA-Floor Problem Areas	Application Date:	February 2014
Substrate:	Concrete		
Products:	Belzona 4911 (TX Conditioner)<span style="white-space: pre;"> </span>, Belzona 4111 (Magma Quartz), Belzona 4521 (Magmaflex Fluid),

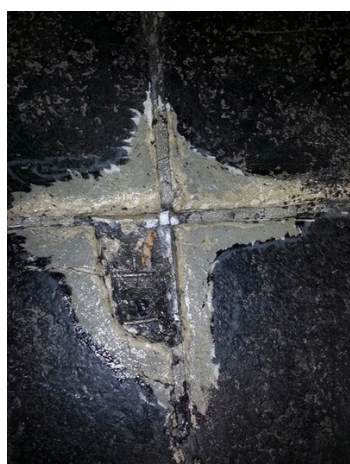
View of application area

Concrete floor of a warehouse in a cement plant was damaged due to heavy traffic of forklifts and trucks, as well as storage of palettes with cement over time. The damage was situated on joint areas of large concrete plates (3m x 5m) of the floor.

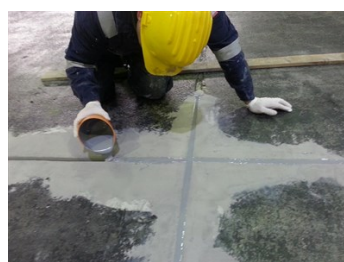
Application in progress

The application was carried out in accordance with Belzona Know-How System Leaflet FPA-1 and FPA-6.

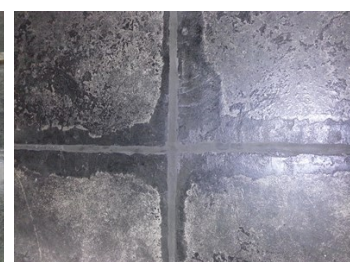
Situation after 8 years in service.
