BELZONA REPAIRS DEFECTS ON HYDRAULIC RAMS

ID: 5991

Customer Location: Hydroelectric Plant, Bulgaria
Application Date: February-March, 2015

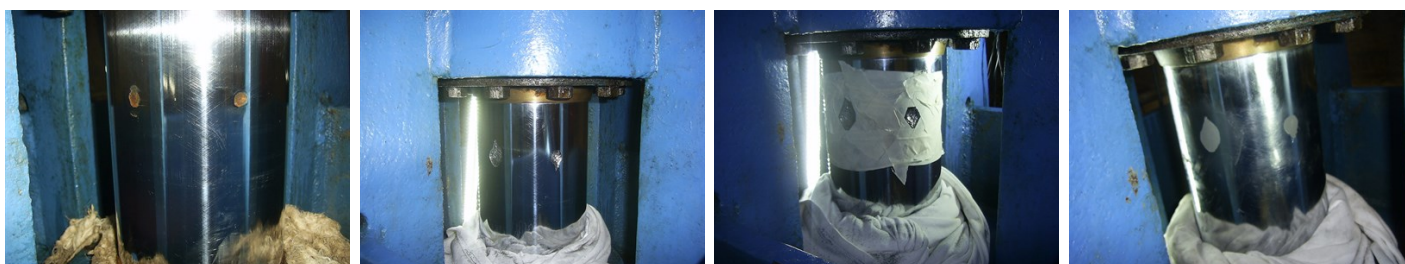
Photograph Descriptions

Ongoing corrosion of point defects in the stainless cladding on the rams had led to the large defects now seen. Sharp edges on the defects could cause damage and rupture of the rubber seals. Repair area was only accessible through a 450x300mm window at the bottom of the hydraulic device.

- * Defects in one of the rams ,
- * Preparation completed ,
- * Masking defects ,
- * Completed application ,

The application was carried out in accordance with Belzona Know-How System Leaflet MPT-3. The area was prepared using a small grinder to roughen and form a dove-tail shape of every defect. After cleaning and masking of the repaired defect Belzona 1111 was applied. Once Belzona 1111 cured, different grades of sandpaper were used to remove excess material and create the required profile with a smooth surface.
