BELZONA REFORMS SEAL FACES IN SHIPS CYLINDER BLOCK

Industry: Marine
Application: ENC-Engines and Casings
Substrate: Cast Iron
Products: * Belzona 1111 (Super Metal) ,
* Belzona 9411 (Release Agent) ,

Customer Location: Naval Ship Repair Yard, Bulgaria
Application Date: January 2015

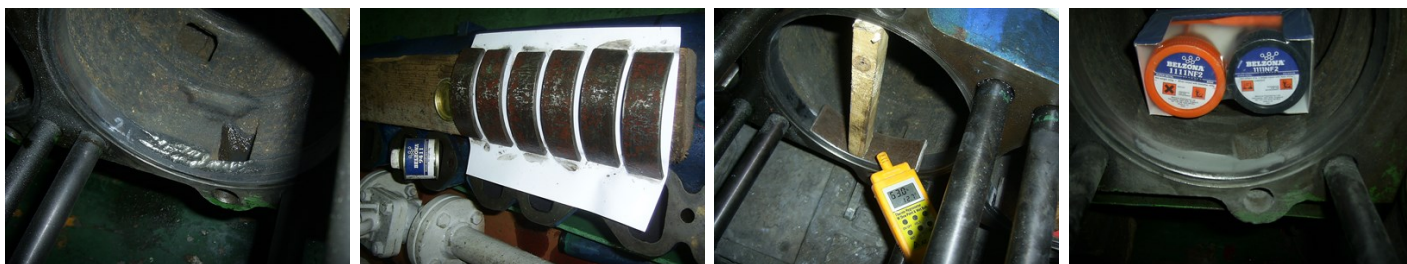
Erosion and corrosion had damaged the seal faces. Conventional repairs were not an option.

- * Preparation of one defect completed ,
- * Forming plates coated with Belzona 9411 ,
- * Application of Belzona 1111 in progress ,
- * Completed application ,

The application was carried out in accordance with Belzona Know-How System Leaflet ENC-5. After preparing the damaged areas, carefully profiled formers coated with Belzona 9411 were used to reform Belzona 1111 to the required seal face dimensions. Once cured, the formers were removed and excess Belzona was trimmed away to leave the accurately formed seal faces.
