O-RING FIT RESTORED WITH BELZONA

ID: 6

Industry: *Power*
Application: *FBC-Fans, Blowers and Compressors*

Customer Location: *Power Plant in North Texas*
Application Date: *1996*

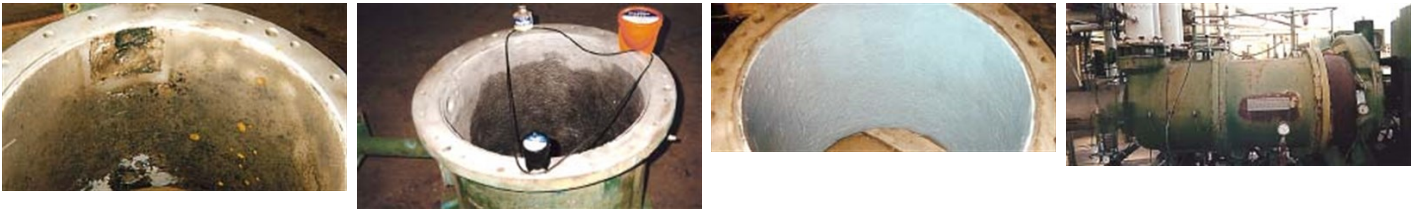
Photograph Descriptions

Eroded O-Ring fit.

- * Corrosion and eroded o-ring fit. ,
- * A new O-Ring was used to form the fit. ,
- * Entire waterbox was coated. ,
- * O-Ring fit restored and back online. ,

Air compressor cooler waterbox.

The application was carried out in accordance with Belzona Know-How Leaflet FBC-5.

Belzona saved costly downtime and restored the operation of the compressor. After several years, the restoration is still holding.
