BELZONA CHILLER PROTECTION

ID: 600

Industry: Heating, Ventilation & Air Conditioning
Application: HEX-Heat Exchangers
Substrate: Steel
Products: * Belzona® 1341 (Supermetalgilde) ,

Customer Location: Five star hotel in Egypt
Application Date: April 2005

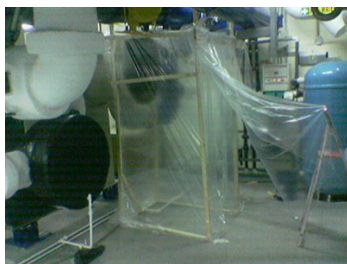
Corrosion of the tube sheet and water box.

- * The corroded water box ,
- * Surface preparation ,
- * Tube sheet completed ,
- * Water box completed ,

Application was carried out in accordance with Belzona Know-How System Leaflet HEX-3.
