BLENDER LINER AT PARTICLE BOARD MANUFACTURER RESTORED WITH BELZONA

ID: 6007

Industry: *Pulp & Paper*
Application: *CEP-Centrifugal Pumps*
Substrate: *Hardened Chromium Alloy Steel*
Products: ** Belzona 1311 (Ceramic R-Metal) ,*
** Belzona 1321 (Ceramic S-Metal) ,*

Customer Location: *Montana, USA*
Application Date: *2003*

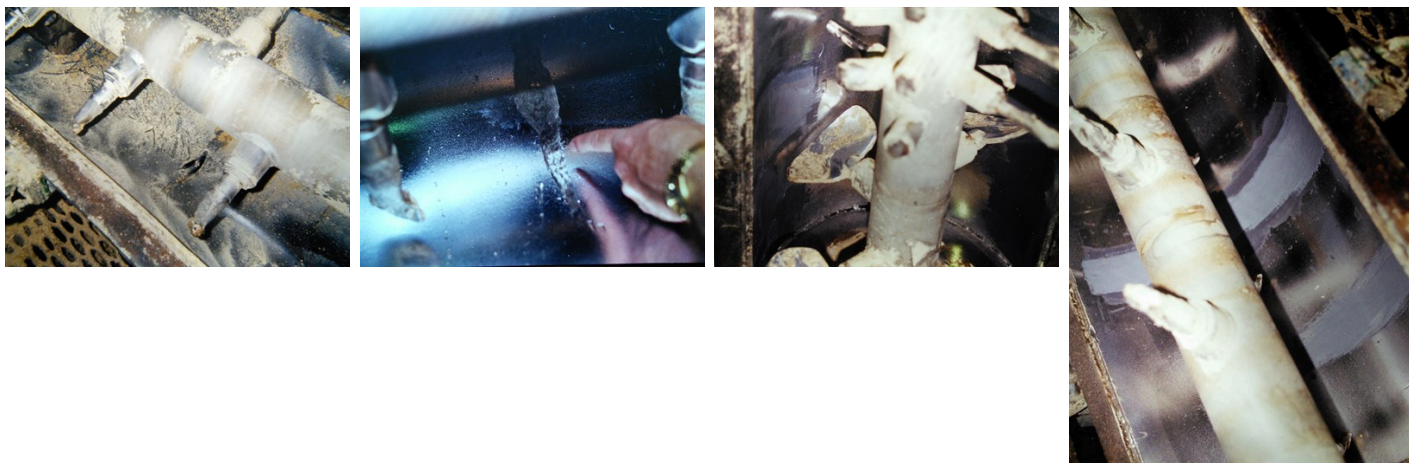
Photograph Descriptions

Wood particles being mixed with resins in this blender caused a very abrasive condition. Even though the liner to this equipment was designed to withstand abrasion it still suffered the effects. Particle board manufacturer was in the habit of welding new liners into this equipment when they wore out. The liner replacements were expensive and time consuming having to remove the worn liner and weld in the new one. This required extensive hot work in a wood laden environment and would typically warp the equipment causing misalignment of the lid.

- * Blender liner showing damage caused by erosion ,
- * Surface preparation completed ,
- * Belzona 1311 applied to the worn areas ,
- * Completed application with Belzona 1321 ,

This application was carried out in accordance with Belzona Know-How System Leaflets CEP-5, CEP-3, and Belzona Instructions For Use.

This repair is much less expensive to perform than component replacement, and does not require as extensive hot work. The Belzona solution is a cold process and does not risk warping of the original equipment. The finish of Belzona 1321 provided a smooth surface preventing the adhesion of wood/resin mixture and still provided abrasion resistance.
