BELZONA PROTECTS HOG FUEL SCREW CONVEYOR

ID: 6009

Industry: Pulp & Paper
Application: SHM-Solids Handling Machinery

Customer Location: Montana, USA
Application Date: 2004

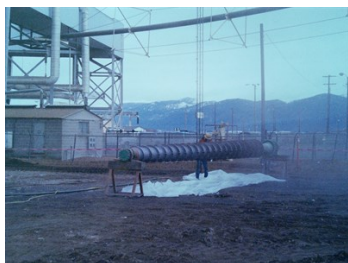
- * Grit Blasting of auger ,
- * Belzona 1812 applied to base of flighting ,
- * Shipping wrap placed over Belzona 1812 to smooth surface ,
- * Full length of auger protected and improved ,

The application was carried out in accordance with Belzona Know-How System Leaflet SHM-14 and Belzona product Instructions For Use.

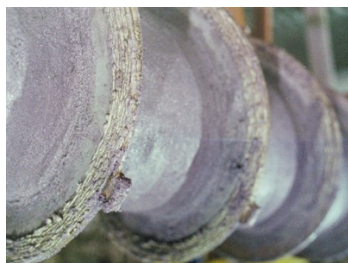
The raw wood supplied to this Pulp and Paper Mill used to burn in the Boiler for process steam was transported to the Boiler house via this auger. The abrasive nature of the media would wear the base of the flighting on this auger.
