# INDUSTRIAL WASTEWATER IMPELLERS REPAIR

ID: 601

Customer Location: Industrial wastewater plant, Egypt

Application Date: April 2003

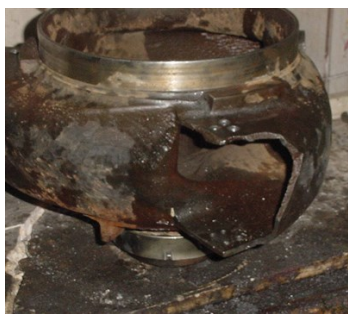
*The edges of impellers were broken due to impact, abrasion and corrosion.*

- \* The broken edges of the impellers ,
- \* Steel sheets inserted to form the leading edges ,
- \* Edges were formed by Belzona® 2111 ,
- \* Final application, coated by Belzona® 2121 ,
