50 YEAR OLD PLINTHS RESTORED WITH BELZONA

Customer Location: Fertiliser Plant, Sweden
Application Date: October 2015

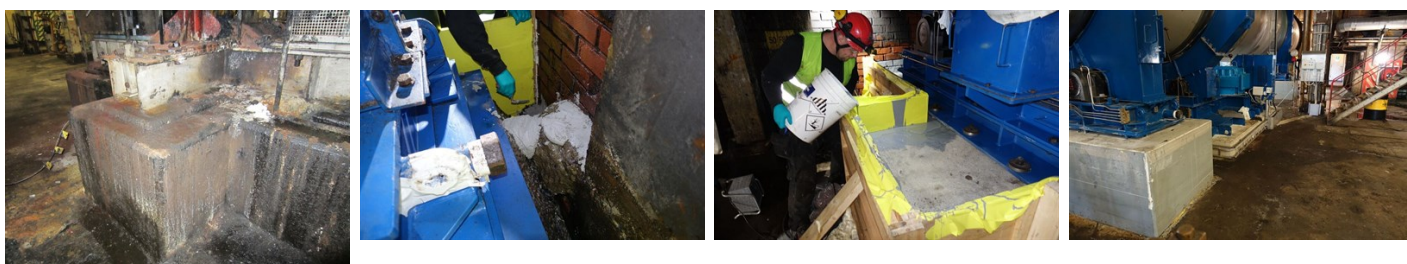
Photograph Descriptions

- * Existing equipment supported by badly corroded concrete plinths ,
- * Belzona 4111 used to build up large gap between equipment and internal wall ,
- * Belzona 5811 and 4151 poured into former ,
- * New equipment with Belzona renovated plinths ,

Brand new machinery was due to be installed in a 50 year old fertiliser plant where the concrete plinths holding the machines were heavily corroded and damaged.

The application was carried out in accordance with a modified version of Belzona Know-How System Leaflet FPA-5. The plinths were thoroughly cleaned and blasted to expose raw concrete underneath. Formers were constructed from plywood and plastic sheet to contain the Belzona products as they were built up. Belzona 4111 was used to build up the large exposed area between the existing plinth and back wall. Belzona 5811 was poured into the formers to create the shape of the new plinth. Belzona 4151 was added as a top layer to fill the top cavities and support the new equipment.
