# FLEXIBLE PROTECTION FOR ACID BUND WITH BELZONA

ID: 6014

Customer Location: Power Plant, Missouri, USA  
Application Date: March 2015

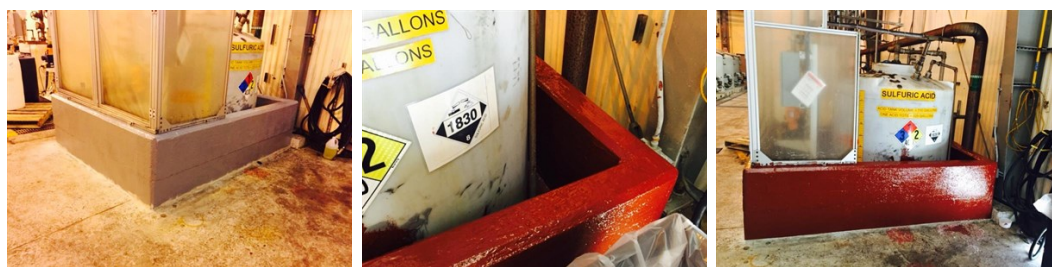
## Photograph Descriptions

*The bund in place to contain spillages from a 93% sulfuric acid tank experienced splashes and spills, resulting in the failure of existing protection. In addition, structural movement resulted in small gaps forming between the floor and bottom of the wall inside the containment area.*

- \* 1. Chemical Bund containing 93% Sulfuric Acid Tank ,
- \* 2. Belzona 4361 applied in two coats ,
- \* 3. Completed application ,

After assessing the problem, the local Belzona Distributor proposed to use Belzona 4361 due to its excellent chemical resistance, flexibility and good adhesion, facilitating long-term sealing between the wall and the floor. The application was carried out in March 2015 and inspected after 9 months with Belzona protection fully intact.
