BELZONA 5811 INJECTION PREVENTS NOZZLE CORROSION

ID: 6021

Customer Location: Gulf of Mexico, USA
Application Date: 2016

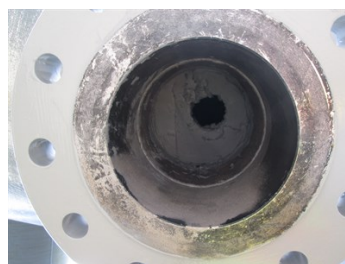
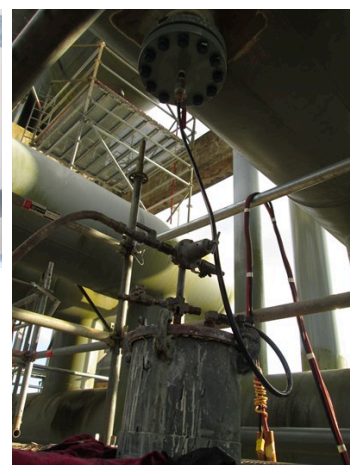
Photograph Descriptions

- * Encapsulation nozzle with blind flange bolted on. ,
- * Cut off old nozzle encapsulated by new nozzle. ,
- * Belzona 1121 used to fill void prior to injection. ,
- * Belzona 5811 injection in progress. ,

Old corroded nozzles were cut off and new encapsulation nozzles of a larger diameter were welded on around the stub from the old cut-off nozzle. Belzona 1121 was used to fill in the void between the old stub and the new encapsulation wall (where an air pocket would have formed). A blind flange tapped for a 3/4 inch hose was then secured to the new encapsulation nozzle. The blind flange had a 3/4 inch hose and ball valve which was connected to a paint pot. The correct calculated volume of Belzona 5811 was then

mixed and set into the paint pot, and air pressure was applied to inject the Belzona 5811 into the encapsulation nozzle. The hose was quickly swapped out for a threaded plug, and the whole encapsulation was wrapped in heat trace elements. After a one hour set up at ambient temperature, the encapsulation was brought to 175°F over a 4 hour period, and then held for two hours to ensure full mechanical cure.
