# BELZONA 5811 INJECTION PREVENTS NOZZLE CORROSION

**Industry:** Chemical & Petrochemical  
**Application:** VPF-Valves, Pipes and Fittings  
**Substrate:** Carbon Steel  
**Products:** \* Belzona 1121 (Super XL-Metal) ,  
\* Belzona 5811 (Immersion Grade) ,

**Customer Location:** Gulf of Mexico, USA  
**Application Date:** 2016

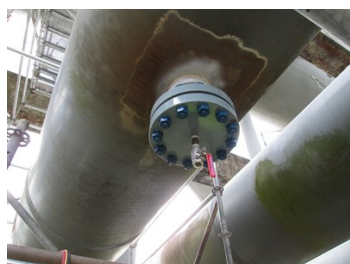
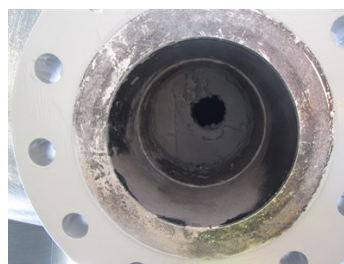
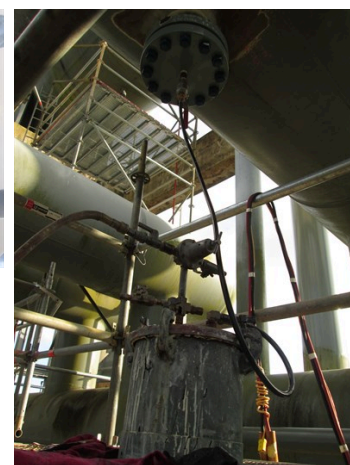
"Dog Leg" nozzles ranging from 2" - 4" were suffering severe corrosion and wall loss due to condensate build-up in the nozzle and lack of draining or cleaning.

- \* Encapsulation nozzle with blind flange bolted on. ,
- \* Cut off old nozzle encapsulated by new nozzle. ,
- \* Belzona 1121 used to fill void prior to injection. ,
- \* Belzona 5811 injection in progress. ,

Old corroded nozzles were cut off and new encapsulation nozzles of a larger diameter were welded on around the stub from the old cut-off nozzle. Belzona 1121 was used to fill in the void between the old stub and the new encapsulation wall (where an air pocket would have formed). A blind flange tapped for a 3/4 inch hose was then secured to the new encapsulation nozzle. The blind flange had a 3/4 inch hose and ball valve which was connected to a paint pot. The correct calculated volume of Belzona 5811 was then

mixed and set into the paint pot, and air pressure was applied to inject the Belzona 5811 into the encapsulation nozzle. The hose was quickly swapped out for a threaded plug, and the whole encapsulation was wrapped in heat trace elements. After a one hour set up at ambient temperature, the encapsulation was brought to 175°F over a 4 hour period, and then held for two hours to ensure full mechanical cure.

Belzona was approached to assist in this project because the Engineers involved had knowledge of Belzona's high adhesion and high mechanical properties. By filling the nozzle encapsulation flush with the flow line, no void exists for condensate to accumulate and begin corrosion cells.
