BELZONA 5811 INJECTION PREVENTS NOZZLE CORROSION

Industry: Chemical & Petrochemical
Application: VPF-Valves, Pipes and Fittings
Substrate: Carbon Steel
Products: * Belzona 1121 (Super XL-Metal) ,
* Belzona 5811 (Immersion Grade) ,

Customer Location: Gulf of Mexico, USA
Application Date: 2016

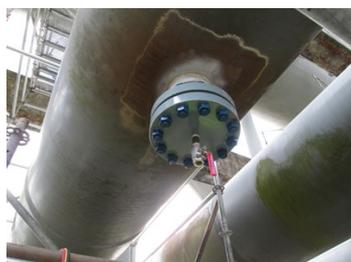
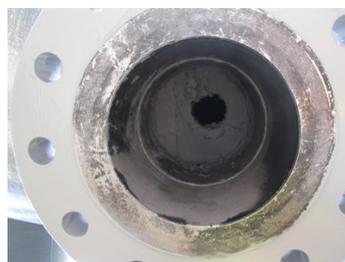
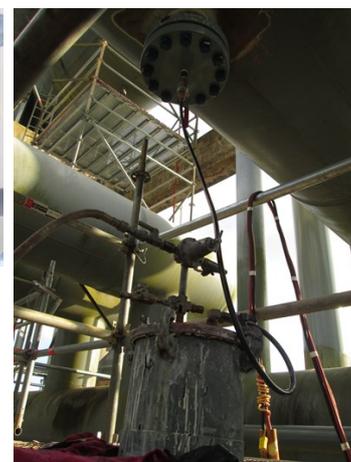
"Dog Leg" nozzles ranging from 2" - 4" were suffering severe corrosion and wall loss due to condensate build-up in the nozzle and lack of draining or cleaning.

- * Encapsulation nozzle with blind flange bolted on. ,
- * Cut off old nozzle encapsulated by new nozzle. ,
- * Belzona 1121 used to fill void prior to injection. ,
- * Belzona 5811 injection in progress. ,

Old corroded nozzles were cut off and new encapsulation nozzles of a larger diameter were welded on around the stub from the old cut-off nozzle. Belzona 1121 was used to fill in the void between the old stub and the new encapsulation wall (where an air pocket would have formed). A blind flange tapped for a 3/4 inch hose was then secured to the new encapsulation nozzle. The blind flange had a 3/4 inch hose and ball valve which was connected to a paint pot. The correct calculated volume of Belzona 5811 was then

mixed and set into the paint pot, and air pressure was applied to inject the Belzona 5811 into the encapsulation nozzle. The hose was quickly swapped out for a threaded plug, and the whole encapsulation was wrapped in heat trace elements. After a one hour set up at ambient temperature, the encapsulation was brought to 175°F over a 4 hour period, and then held for two hours to ensure full mechanical cure.

Belzona was approached to assist in this project because the Engineers involved had knowledge of Belzona's high adhesion and high mechanical properties. By filling the nozzle encapsulation flush with the flow line, no void exists for condensate to accumulate and begin corrosion cells.
