SEAWATER FIRE PUMP REPAIR WITH BELZONA

Application: CEP-Centrifugal Pumps

Customer Location: Houston, TX, USA

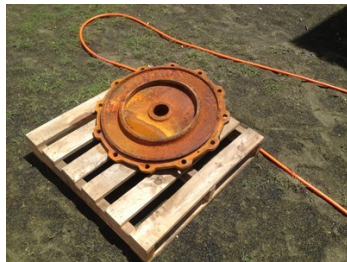
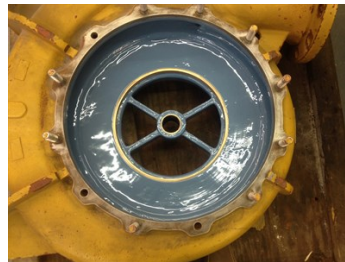
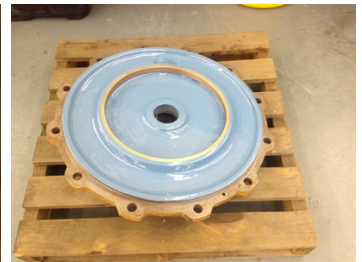
Photograph Descriptions

The customer was having problems with severe corrosion on the pumps due to them being idle for months at a time, often after only a few years of use they were being replaced with new ones.

- * Severely corroded pump ,
- * Corroded pump end-cover ,
- * Pump after the application ,
- * Pump end-cover after the application ,

The application was carried out in accordance with a modified version of Belzona Know-How System Leaflet CEP-3.

For a fraction of the cost of a new pump the customer is now having his pumps repaired with Belzona products. This not only offers significant savings, but the coated pumps last in service 3 times longer than the originals.
