BELZONA RESCUES A PIPELINE AT THE CRUNCH TIME

ID: 6040

Industry: Oil & Gas
Application: SOS-Ships and Offshore Structures

Customer Location: Gulf of Mexico, USA
Application Date: March 2016

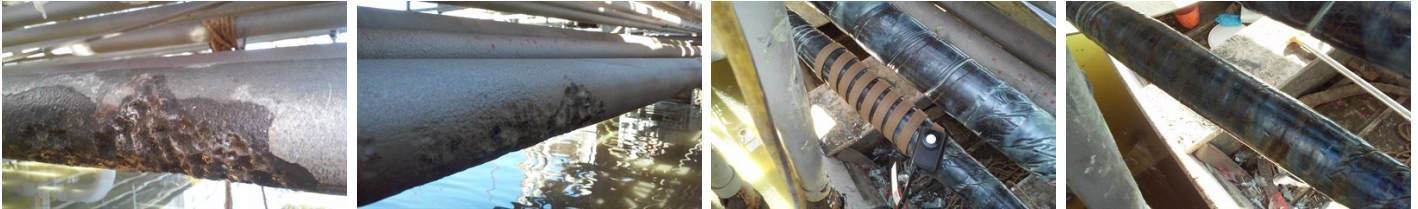
Photograph Descriptions

- * Original condition. Significant exterior corrosion causing wall loss. ,
- * After abrasive blasting shows several holes. ,
- * Post curing composite wrap with heat tape. ,
- * Completed application. ,

Customer had two ethyl glycol lines needing repair. The pipes were located near the waterline and access was difficult. One pipe had several through-wall defective areas whereas the other had thin-wall defects.

Belzona 1511 was used to fill pits and rebuild the wall thickness lost. 5 layers of Belzona 9381 wetted with Belzona 4981 were applied with 50% overlap. Belzona 9382 was used to consolidate the repair. The system was allowed to cure at ambient temperature for 24 hours, then post cured at 200°F for 6 hours.
