# BELZONA FILLS THE GAP BETWEEN SKID AND DECK

ID: 6042

Industry: Oil & Gas  
Application: SOS-Ships and Offshore Structures

Customer Location: Gulf of Mexico, USA  
Application Date: February 2016

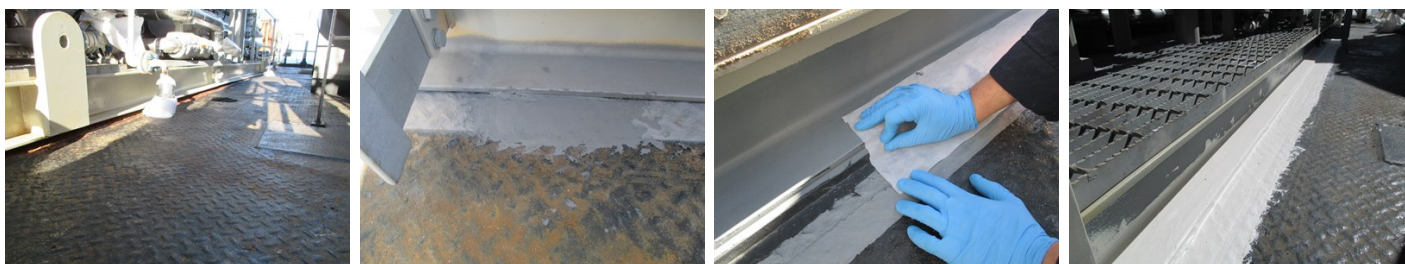
- \* Gap between skid and deck. ,
- \* Holes in deck repaired with Belzona 1121. ,
- \* Surfaces primed with Belzona 3921 and gap filled with Belzona 2211. Belzona 9331 is test fitted to bridge interface. ,
- \* Completed application with Belzona 3111. ,

A new skid package was welded to the deck but did not sit flush, due to uneven surfaces. The deck was losing metal from corrosion and had several holes in it.

The areas of the deck suffering from metal loss were repaired with Belzona 1121. Then, all surfaces were primed with Belzona 3921 prior to using Belzona 3111 as a flexible sealant. The gap between the deck and skid was filled with Belzona 2211. Belzona 9331 was

saturated with Belzona 3111 to bridge over interface.
