BELZONA STOPS LEAKS AND PROTECTS PARKED CARS

Industry: Buildings & Structures
Application: VPF-Valves, Pipes and Fittings
Substrate: Carbon Steel
Products: * Belzona 1161 (Super UW-Metal) ,
* Belzona 5111 (Ceramic Cladding) ,

Customer Location: Houston, TX, USA
Application Date: December 2015

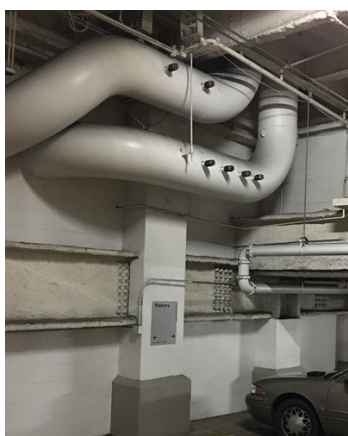
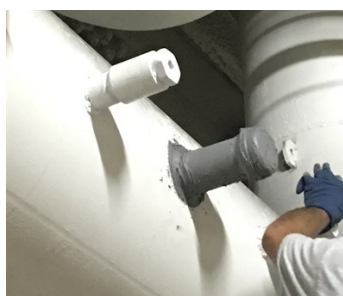
Photograph Descriptions

Cooling tower line drains were leaking and causing damage to the paint of vehicles parked below. Aesthetics were important to the client. Not only did they need the leak stopped, they also needed a solution that would not be an eye-sore to their tenants.

- * Before Application ,
- * After surface preparation ,
- * Belzona 1161 used to apply cap to leaking area ,
- * Complete project with Belzona 5111 used to match the existing paint on the line ,

The application was carried out with a modified version of Belzona Know-How System Leaflet VPF-15.

The Belzona application was carried out in half a day and the customer was in service during the repair. Alternative methods would have taken the cooling tower offline for 2-3 days, leaving tenants uncomfortable and the cost much more expensive.
