# BELZONA STOPS LEAKS AND PROTECTS PARKED CARS

ID: 6043

**Industry:** Buildings & Structures  
**Application:** VPF-Valves, Pipes and Fittings  
**Substrate:** Carbon Steel  
**Products:** \* Belzona 1161 (Super UW-Metal) ,  
\* Belzona 5111 (Ceramic Cladding) ,

**Customer Location:** Houston, TX, USA  
**Application Date:** December 2015

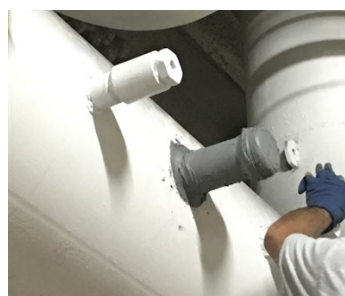
Cooling tower line drains were leaking and causing damage to the paint of vehicles parked below. Aesthetics were important to the client. Not only did they need the leak stopped, they also needed a solution that would not be an eye-sore to their tenants.

- \* Before Application ,
- \* After surface preparation ,
- \* Belzona 1161 used to apply cap to leaking area ,
- \* Complete project with Belzona 5111 used to match the existing paint on the line ,

The application was carried out with a modified version of Belzona Know-How System Leaflet VPF-15.

The Belzona application was carried out in half a day and the customer was in service during the repair. Alternative methods would have taken the cooling tower offline for 2-3 days, leaving tenants uncomfortable and the cost much more expensive.
