# BELZONA REPAIRS AND SAVES INTERNALS OF WASTEWATER PIPE

ID: 6045

Customer Location: Water Treatment Plant, Bossier City, LA, USA

42" Ductile Iron underground pipe.

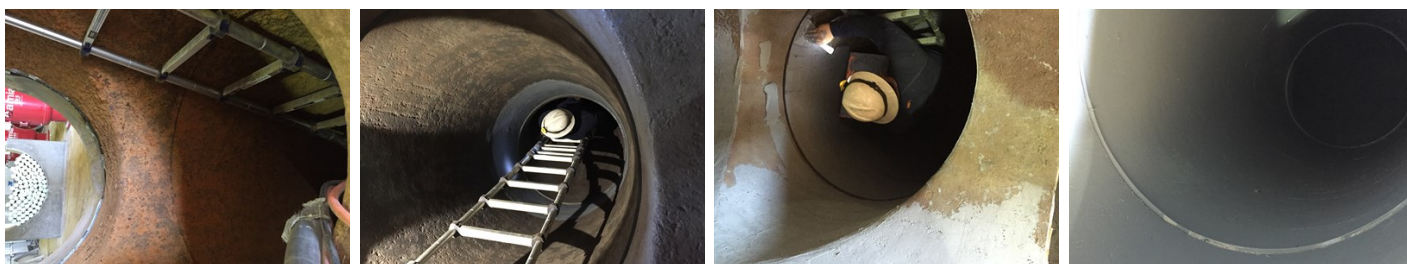
The pipe was corroded so badly that the pitting was causing pin holes in the substrate.

- \* Corroded pipe before application. ,
- \* Internals of pipe after SP-10 Abrasive Blast. ,
- \* Applicators applying Belzona 1121 to pitting. ,
- \* The pipe after being coated with Belzona 5811. ,

The application was carried out in accordance with a modified version of Belzona Know-How System Leaflet VPF-5. Belzona 1121 was used to rebuild the pitting. Belzona 5811 was used to coat the internal of the pipe.
