# BELZONA REBUILDS CLARIFIER RUNNING TRACK

Industry: Water / Wastewater  
Application: FPA-Floor Problem Areas  
Substrate: Concrete  
Products: \* Belzona® 4111 (Magma-Quartz),  
\* Belzona® 4911 (Magma TX Conditioner),

Customer Location: Sewage farm - Switzerland  
Application Date: 2003

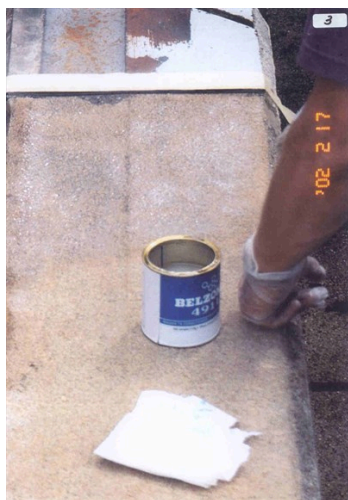
The wheels had caused between 2mm and 10mm wear to the concrete and were not running smoothly.

- \* The clarifier track ,
- \* Conditioning the surface with Belzona® 4911 ,
- \* Rebuilding with Belzona® 4111 ,
- \* The finished track ,

The track was rebuilt with Belzona® 4111 in accordance with Belzona Know-How System Leaflet FPA-1.
