BELZONA REBUILDS CLARIFIER RUNNING TRACK

ID: 605

Customer Location: Sewage farm - Switzerland
Application Date: 2003

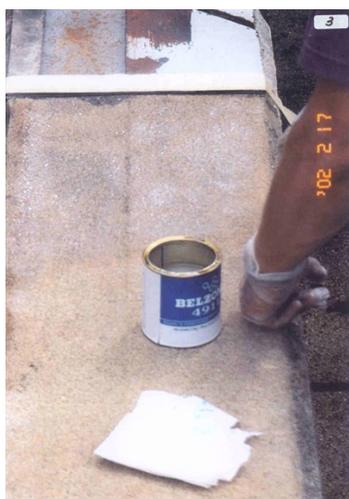
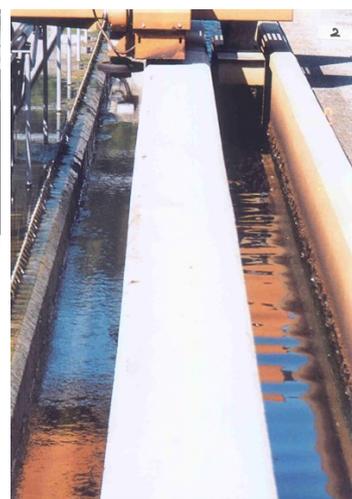
The wheels had caused between 2mm and 10mm wear to the concrete and were not running smoothly.

- * The clarifier track ,
- * Conditioning the surface with Belzona® 4911 ,
- * Rebuilding with Belzona® 4111 ,
- * The finished track ,

The track was rebuilt with Belzona® 4111 in accordance with Belzona Know-How System Leaflet FPA-1.
