BELZONA REPAIRS RUBBER LINED VALVES

ID: 6056

Customer Location: Pump/Valve Repair Shop, Saudi Arabia
Application Date: January 2016

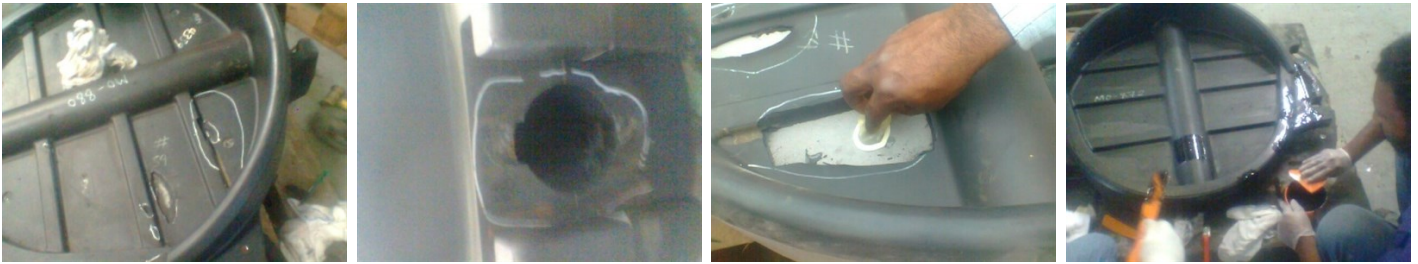
Photograph Descriptions

Damage to the existing rubber lining had resulted in corrosion damage to the exposed steel substrate.

- * View of existing lining damage ,
- * Another area of lining damage ,
- * Surface preparation including Chloride Test for salt contamination ,
- * Completed application ,

Application was carried out in accordance with Belzona Know-How System Leaflet VPF-3. Areas of damaged rubber lining were cut away and the exposed steel substrate was prepared by grit blasting. Following the application of Belzona 2911, the damaged areas were rebuilt using Belzona 2111.
