LOCALIZED BELZONA REPAIRS TO RUBBER LININGS

ID: 6060

Industry: Power

Customer Location: Power Plant, UK

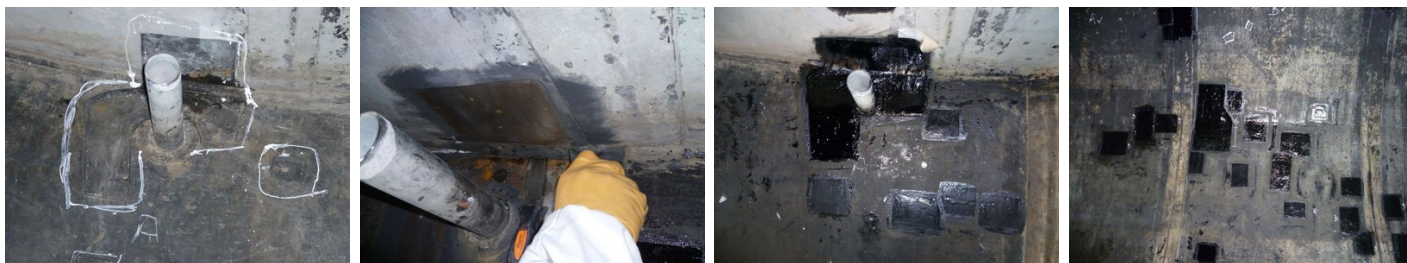
Photograph Descriptions

- * Defect areas marked up in a water treatment tank ,
- * Failed neoprene rubber lining being removed ,
- * Completed repairs with Belzona 2111 ,
- * Further repairs completed on tank walls ,

Application was carried out in accordance with Belzona Know-How System Leaflet TCC-3. After preparing the substrate, Belzona 2911 was applied before repairing the rubber lining with Belzona 2111.
