PINTLE PIN AND HOUSING REBUILT WITH BELZONA

ID: 6064

Rudder pintle pin and housing on a large ship.

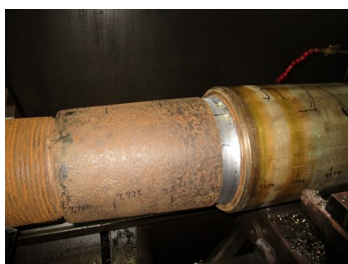
Seawater had corroded the pintle pin and housing enough so that the pin was a loose fit in the housing.

- * Pintle pin showing corrosion. ,
- * Pintle pin rebuilt and ready to form new housing. ,
- * Pintle housing showing corrosion before grit blasting. ,
- * Pintle housing rebuilt, ready for final assembly with Belzona 2111 sealing both ends. ,

The worst of the corrosion on the pin was undercut on a lathe and rebuilt with Belzona 1111. Next, the pintle housing was grit blasted and coated with Belzona 1111. The pin was coated with a release agent and lifted into the housing to form a perfect fit. The rebuilt housing was inspected and then reassembled using Belzona 2111 to seal the top and bottom of the pintle housing.
