BELZONA SEALS LEAKING HEAT EXCHANGER PIPE

ID: 6075

Customer Location: Veneer Manufacturer, Northumberland, UK

Application: VPF-Valves, Pipes and Fittings

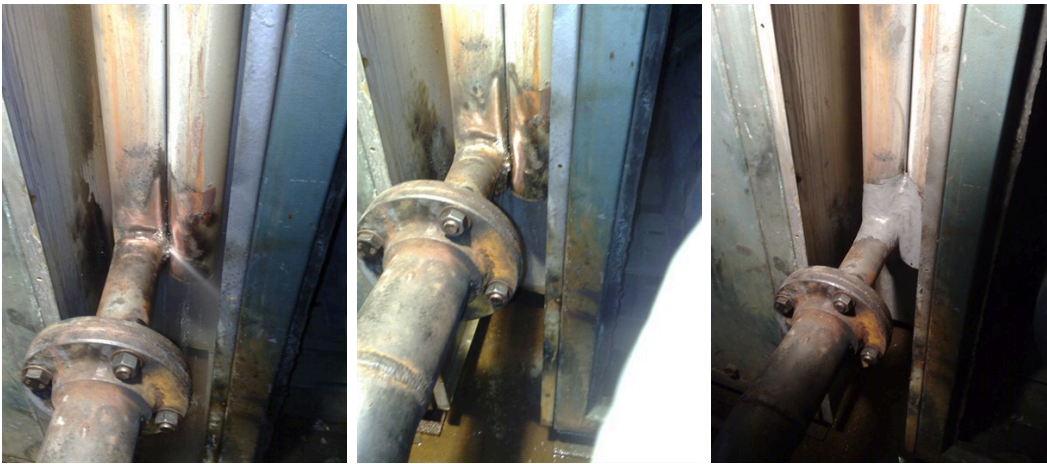
Photograph Descriptions

Customer had made several attempts to braze the leak without success due to the thin wall nature of the copper pipework. The nature of the continuous leak was creating a safety hazard.

- * Leaking pipework ,
- * Pipework manually prepared ,
- * Pipework repaired ,

Pin hole leak on T Junction of the heat exchanger pipework.

The application was carried out in accordance with Belzona Know-How System Leaflet VPF-11 after draining the system.

The repair was carried out with minimal downtime and negated hot work, which had been tried unsuccessfully the first time. The

Belzona solution removed the Health & Safety risk whilst also providing a permanent repair.
