BELZONA TACKLES AN EXPLOSIVE SITUATION

ID: 6078

Customer Location: Steel producer, Czech Republic
Application Date: October 2015

The gas supply line for a blast furnace

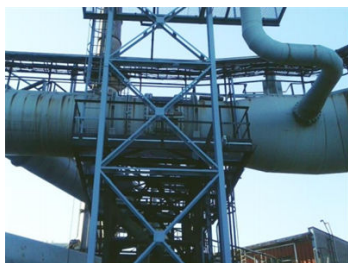
Pipeline had developed a crack which was leaking gas into the atmosphere. The repair had to be performed live. The intake pipe had a diameter of 2,000mm and had developed a crack 2,500mm long and 2mm wide.

- * The damaged pipework ,
- * Applying the first seal of Belzona 1211 ,
- * Main layer of Belzona 1111 and sheet applied ,
- * Completed application ,
