BELZONA SAVES OIL COOLER FROM SCRAP HEAP

Industry: Power
Application: HEX-Heat Exchangers
Substrate: Steel
Products: * Belzona® 1311 (Ceramic R-Metal) ,
* Belzona® 1321 (Ceramic S-Metal) ,

Customer Location: Coal fired power station - Germany
Application Date: 2004

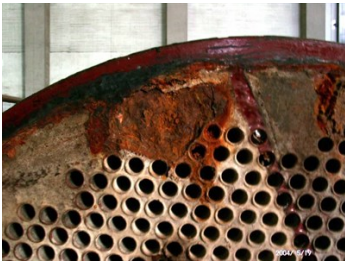
After 40 years in service the oil coolers were suffering from severe corrosion.

- * Corroded tubesheet ,
- * Completed tubesheet ,
- * Tubesheet at opposite end ,
- * Close-up ,

The corrosion damage was rebuilt with Belzona® 1311 and coated with Belzona® 1321 in accordance with Belzona System Leaflets HEX-1 and HEX-3.

The cooler had been in service for nearly 40 years and the manufacturer had recommended replacement. The repair included reseating the retaining bolts and cost a fraction of replacement.
