BELZONA SAVES OIL COOLER FROM SCRAP HEAP

ID: 608

Customer Location: Coal fired power station - Germany
Application Date: 2004

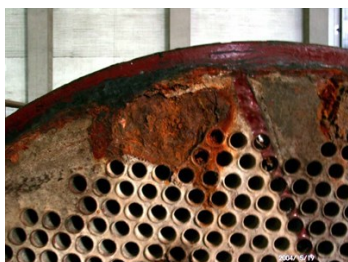
After 40 years in service the oil coolers were suffering from severe corrosion.

- * Corroded tubesheet ,
- * Completed tubesheet ,
- * Tubesheet at opposite end ,
- * Close-up ,

The corrosion damage was rebuilt with Belzona® 1311 and coated with Belzona® 1321 in accordance with Belzona System Leaflets HEX-1 and HEX-3.
