BELZONA UPGRADES BASEMENT TO PLANT ROOM USE

ID: 6086

Industry: *Buildings & Structures*
Application: *FPA-Floor Problem Areas*

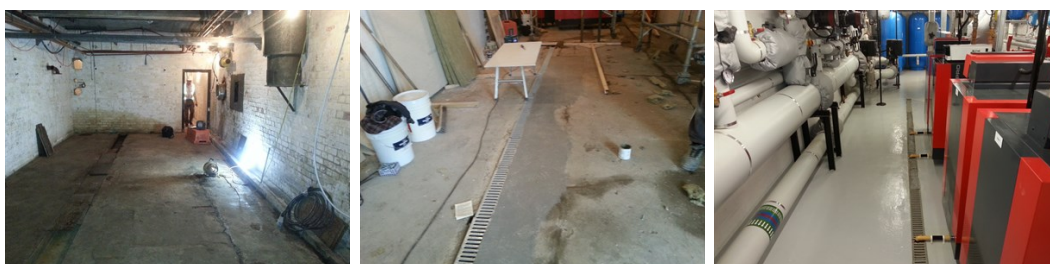
Photograph Descriptions

The existing concrete floor had many broken and damaged areas and the steep steps down into the basement were smooth and slippery

- * Disused basement before ,
- * Belzona 4111 and 4131 being installed to repair floor ,
- * Completed plant room with floor coated with Belzona 5231 ,

The application was carried out in accordance to Belzona Know-How System Leaflets FPA-1 and FPA-8. Belzona 4111 and 4131 were used to repair and level the damaged concrete areas and then the steps and floor were coated with Belzona 5231.
