3-STEP BELZONA CAVITATION SOLUTION FOR KAPLAN TURBINE BLADES

ID: 6087

Customer Location: Hydroelectric Plant, Northern Italy
Application Date: March 2016

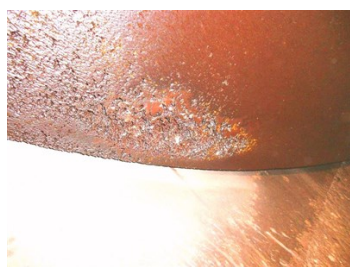
Four blades of the Kaplan turbine were experiencing metal loss as a result of cavitation. In some areas, through-wall defects started to appear. The customer previously attempted to repair the damage by welding without success.

- * Cavitated turbine blades ,
- * Rebuilding with Belzona 1311 ,
- * Belzona 1341 applied ,
- * Belzona 2141 applied onto the edges ,

The application was carried out in accordance with Belzona Know-How System Leaflets CEP-1 and CEP-3. After surface preparation was carried out, a 3-step repair and protection system against cavitation was applied. STEP 1: Belzona 1311 was used to rebuild and restore profile of the damaged surfaces. STEP 2: Entire surface area of the blades was then coated with Belzona 1341 to protect them from erosion-corrosion. STEP 3: Finally, areas subjected to cavitation were protected with cavitation resistant Belzona 2141.
