BELZONA KEEPS THE FLOW GOING

Industry: General Industry
Application: CEP-Centrifugal Pumps
Substrate: Cast iron
Products: * Belzona 1111 (Super Metal) ,
* Belzona 1341 (Supermetalgilde) ,

Customer Location: Tire Manufacturer, Czech Republic
Application Date: March 2015

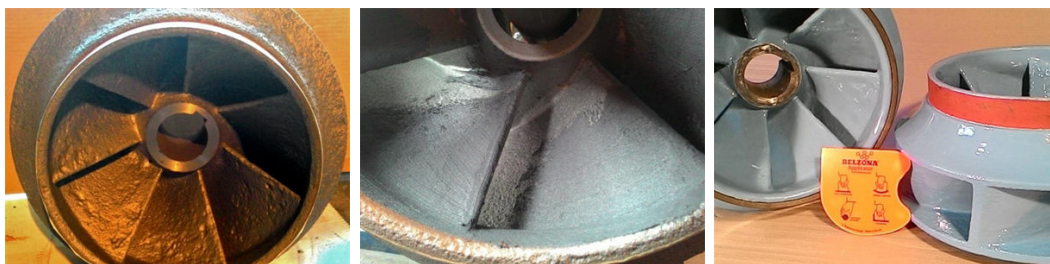
Photograph Descriptions

Impeller vanes on water pumps had been damaged by cavitation erosion corrosion, leading to reduced efficiency.

- * The damaged impeller ,
- * Surface profile being restored with Belzona 1111 ,
- * Impellers finished with Belzona 1341 ,

Application was carried out in accordance with Belzona Know-How System leaflet CEP-10. Original profiles were restored with Belzona 1111 before applying two coats of Belzona 1341 to provide future erosion corrosion protection to the impellers.

The application of Belzona 1111 restored the original surface profile, allowing the client to avoid the expense of a total part replacement. The Belzona 1341 then added a layer of protection, preventing the recurrence of cavitation or corrosion damage and simultaneously improving flow rates thanks to the smooth surface.
