# UNDERGROUND PIPE REPAIRED WITH BELZONA SUPERWRAP II

**Customer Location:** Petrochemical Company, Chonburi, Thailand

**Application:** VPF-Valves, Pipes and Fittings

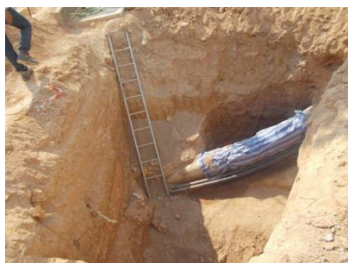
Internal local corrosion, detected by inspection pig, had created a thin-wall defect in the pipe, which had a design pressure rating of 100 bar(g).

- \* The damaged pipe ,
- \* Grit blasting the surface ,
- \* First layer of Belzona 9381 and Belzona 1982 applied ,
- \* Final layer of Belzona 1982 applied ,
