# WATER SUPPLY SAVED BY BELZONA

ID: 6096

Industry: Marine  
Application: ENC-Engines and Casings  
Substrate: Mild Steel with soft synthetic coating  
Products: \* Belzona 1111 (Super Metal) ,  
\* Belzona 9411 (Release Agent) ,

Customer Location: Military Research Ship  
Application Date: May 2016

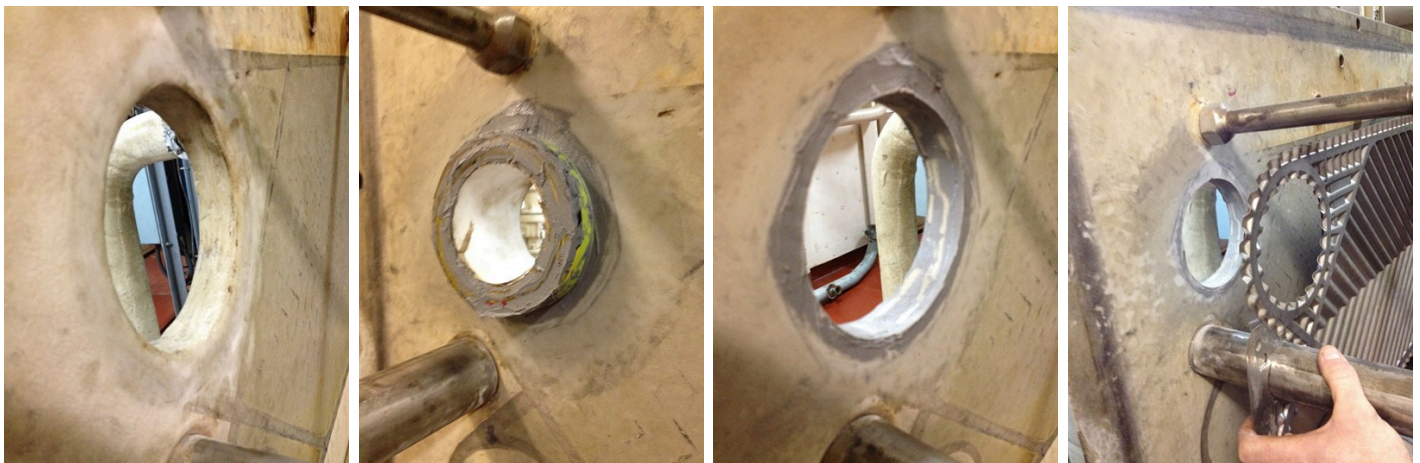
## Photograph Descriptions

Sealing surface repairs seemed very difficult because of precision needed to seal flat plate heat exchangers within the distillation plant. Ship's schedule did not allow enough time for backing plate overhaul. Basic instruction assistance was provided by Belzona consultant and allowed ships force engineers to complete rapid, permanent repair and get the water maker back in service. Soft backing plate coating failed on sealing surface and prevented double face rubber gasket from sealing sea water flow in a Alfa Laval Flash Type sea water Distiller.

- \* Eroded bore in backing plate ,
- \* Former in place ,
- \* Square edge of sealing surface restored ,
- \* Repair complete and ready for reassembly ,

Ship's potable water supply was reduced by half for over 8 months by a leak.

Ports with FORMING Technique. Former was created matching the required outside dimension. Release agent was applied to former after preparing substrate by hand with course sand paper. Belzona 1111 was applied to bore of damaged area and smoothed off with 90 degree side of application tool. Former was removed after a few hours and sealing surface dressed by draw filing.

With only a small amount of Belzona 1111 and release agent a costly resurfacing effort of the backing plate and continued loss of water production for ship was prevented. Savings are not just in expense but the difficulty of traditional repairs requiring shipyard services, rigging heavy components, scheduling around sailing schedules and inconvenience to crew. New skill was added to the ship's engineering crew.
