BELZONA REPAIRS PINHOLES IN HEATER DRUM

ID: 6101

Customer Location: Offshore Platform, Gabon
Application Date: April 2016

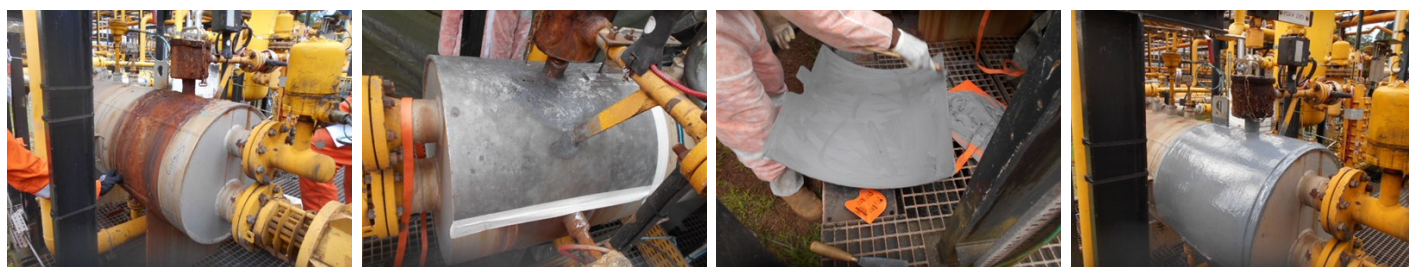
Photograph Descriptions

Corrosion Under Insulation had caused pinholes in the tank wall. An in-situ was required to ensure minimal disruption to production.

- * Tank suffering from corrosion under insulation ,
- * After surface preparation ,
- * Plate cut and ready to bonded with Belzona 1111 ,
- * Finished application after coating with Belzona 1321 ,

Application was carried out in accordance with Belzona Know-How System Leaflet TCC-1. After surface preparation had been carried out, a custom-made plate was bonded using Belzona 1111. The plate was cut to fit the nozzle and brackets on the tank and was grit blasted prior to going offshore. As an additional protection, Belzona 1321 was applied on top of the plate to prevent future issues with corrosion under insulation.

The temperature at the time of the application was dropped down to 40°C. The work was completed over 1 shift which was greatly appreciated by the offshore operator and ensured production could continue with minimal disruption.
