# BELZONA REBUILDS CAVITATED VANES

**Industry:** Power  
**Application:** CEP-Centrifugal Pumps  
**Substrate:** Cast iron  
**Products:** \* Belzona® 1311 (Ceramic R-Metal) ,  
\* Belzona® 1321 (Ceramic S-Metal) ,

**Customer Location:** Power plant, Egypt  
**Application Date:** April 2004

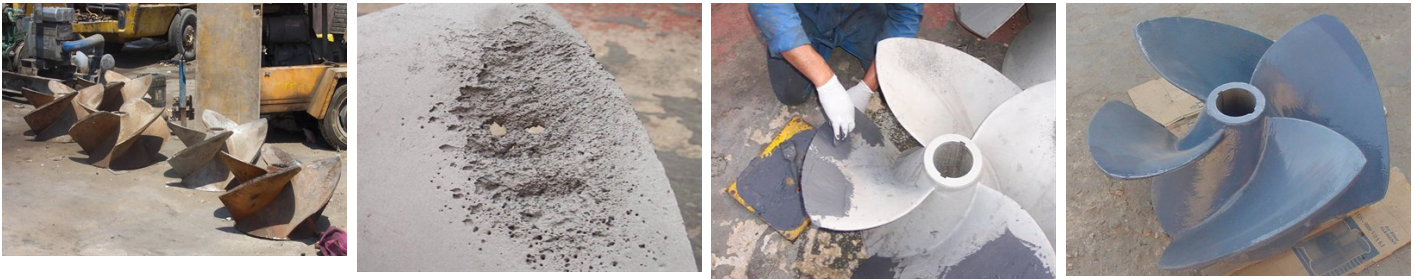
Severe cavitation caused holes, pittings and deformation in the profile of the vanes.

- \* General view of the five impellers ,
- \* The cavitated vanes ,
- \* Rebuilding the vanes using Belzona® 1311 ,
- \* Finished Impellers coated with Belzona® 1321 ,

Application was carried out in accordance with Belzona Know-How System Leaflets CEP-3 and CEP-5.

Belzona rebuilt the cavitation and pitting damage in the vanes restoring the correct profile using a simple technique, saving replacement costs and also providing more resistance to future cavitation.
