# BELZONA REBUILDS THE WALLS OF A SECONDARY CONTAINMENT AREA

**Customer Location:** Cement Plant, Oregon, USA  
**Application Date:** September 2015

Concrete walls of an ammonia secondary containment area.

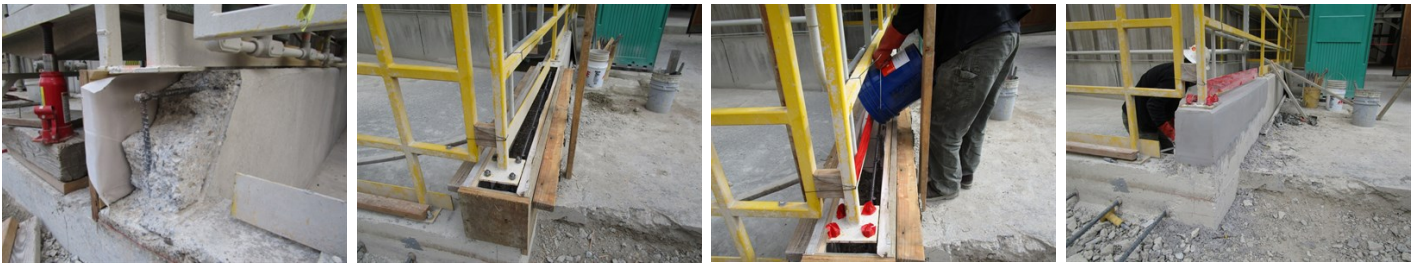
Severe cracks and damage in the walls of the ammonia secondary containment due to design issues.

- \* Showing damage to the walls ,
- \* Forming boards used for the application of Belzona 4154 ,
- \* Pouring of Belzona 4154 ,
- \* Completed application showing Belzona 4111 as a top layer ,

The damage at the SE corner required cutting out a section of the walls in one area and a simple removal of a small section at the SW corner. A grinder was used to remove oxidation from rebar. Belzona 4911 was applied to the steel rebar and concrete. Form boards were attached to the concrete to create a frame before pouring Belzona 4154. Once cured, the form boards were removed. A grinder was used to remove the gloss off of Belzona 4154, then the surface was wetted with Belzona 4911 to prepare it for the application of Belzona 4111 as a finishing layer.
