BELZONA SAVES ROOFING CONTRACTORS REPUTATION

Application: *RPA-Roof Problem Areas*

Substrate: *Roofing felt*

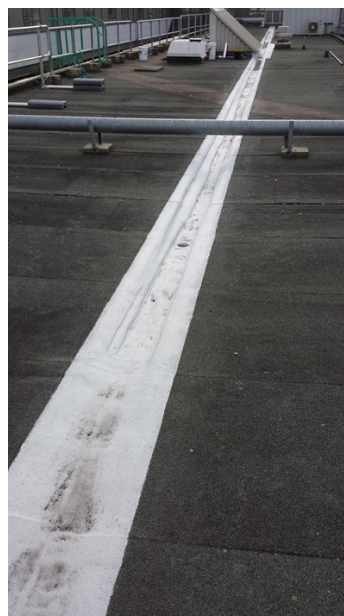
Photograph Descriptions

Multiple rips along the gutter dues to the existing material not being flexible enough.

This flat roof gutter had been leaking previously and in an attempt to solve the problem the contractor had used a competitive material that proclaimed itself to be a highly flexible membrane. In fact, the contractor had used the same product on several roofs in the hospital and most had failed. The contractor was getting no support from the material manufacturer and he was worried for his reputation with this important client. For this particular gutter section, the application had been repeated and the competitive product had again failed. Belzona were called in by the contractor to save his reputation and solve the leaks once and for all. On close inspection it could be seen that the competitive product was not flexible enough and there were dozens of small rips along the gutter.

- * Roof gutter on initial inspection. ,
- * Damage to competitive product close up. ,
- * Completed Belzona 3111 application. ,

The application was carried out in accordance with a modified version of Belzona Know-How System Leaflet RPA-6.

The Belzona membrane was applied directly onto the previous coating which reduced the costs and when the application was revisited 2 years later the Belzona was still perfect. Belzona have an excellent track record in supporting their materials and have been producing roofing materials since 1966. In the words of the contractor, "The cheaper competitive product had nearly destroyed our reputation and we would have never recovered without help from Belzona".
