CHEMICAL BUILDING ROOF LEAK REPAIRED BY BELZONA 3111

ID: 6118

Customer Location: Chemical Company, Thailand
Application Date: November 2011

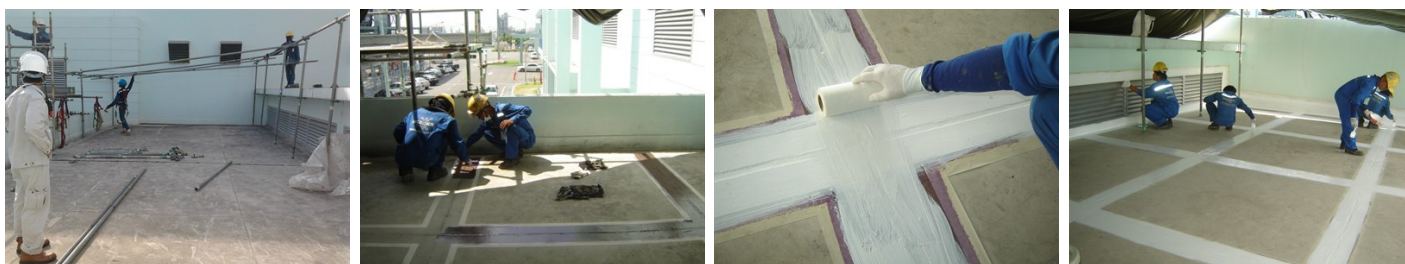
Photograph Descriptions

Leaks at roof joints allowed water to leak through causing damage to the chemicals stored below.

- * 1. Overall picture of the area that need to be repaired ,
- * 2. Belzona 3911 was applied ,
- * 3. First coat of Belzona 3111 incorporating Belzona 9311 Reinforcement sheet being applied ,
- * 4. Ongoing application of Belzona 3111 system to all roof joints ,

Application was carried out in accordance with Belzona Know How System Leaflet RPA-1 and RPA-2. The fully reinforced Belzona 3111 System was applied to bridge all joints on the roof.
