# CHEMICAL BUILDING ROOF LEAK REPAIRED BY BELZONA 3111

ID: 6118

Customer Location: Chemical Company, Thailand  
Application Date: November 2011

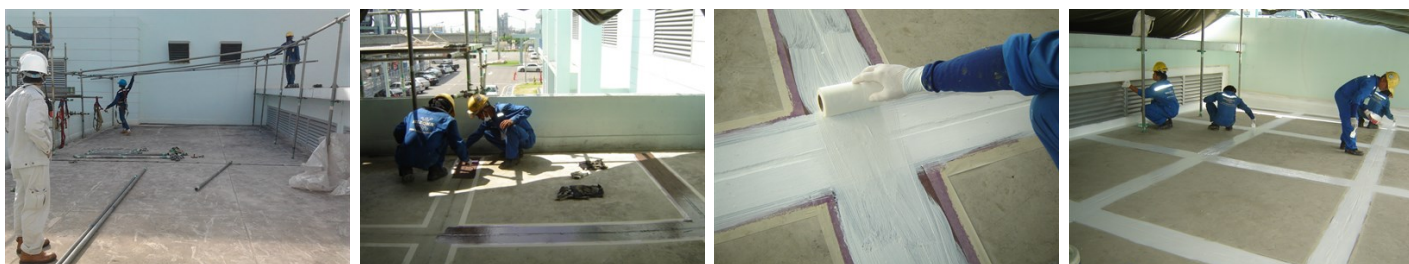
## Photograph Descriptions

Leaks at roof joints allowed water to leak through causing damage to the chemicals stored below.

- \* 1. Overall picture of the area that need to be repaired ,
- \* 2. Belzona 3911 was applied ,
- \* 3. First coat of Belzona 3111 incorporating Belzona 9311 Reinforcement sheet being applied ,
- \* 4. Ongoing application of Belzona 3111 system to all roof joints ,

Application was carried out in accordance with Belzona Know How System Leaflet RPA-1 and RPA-2. The fully reinforced Belzona 3111 System was applied to bridge all joints on the roof.
