# STEEL PLATE BONDING WITH BELZONA 1511 FOR BRIDGE

Customer Location: Rama IX Bridge, Bangkok, Thailand

Application Date: 17 November 2015

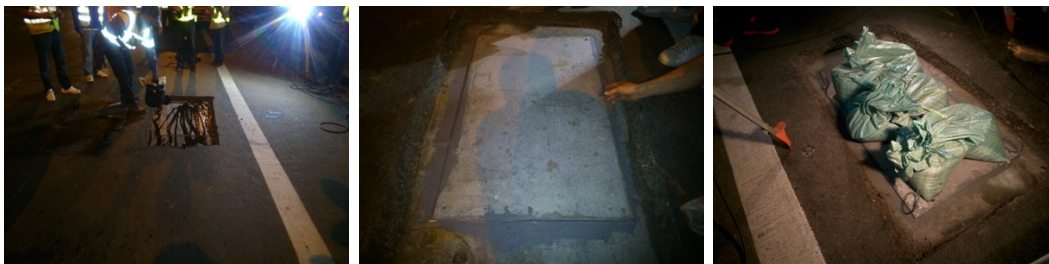
- \* 1. Belzona 1511 was applied on the repair area and on the prepared area of steel plate. ,
- \* 2 and 3 Place the steel plate on the repair area. ,

Steel deck of Rama IX Bridge was cracked.

Drill a hole on the steel plate and tap in the screw to tighten the hook screw. The repair area was prepared with grit blasting and remove oil, grease, and contamination with MEK. And then, mix Belzona 1511 and apply it on the repair area and on the prepared area of steel plate, place plate on the repair area and leave cure. After that cut the hook screw and fill the asphalt to achieve the existing level.
